TEST REPORT ENVIRONMENTAL EN 60529:1991+A1:2000	
Report Reference No.	: 93702-1TRFENV
Tested by	: Cristian Simone <i>Cristian Simone</i>
Verified by	: Daniele Claudio Mapelli <i>Daniele Claudio Mapelli</i>
Date of issue	: 2007-09-28
Testing Laboratory	: Nemko Spa
Address.....	: Via del Carroccio, 4, I-20046 Biassono MI (Italy)
Testing location/ procedure	: Full application of Harmonised standards <input checked="" type="checkbox"/> Partial application of Harmonised standards <input type="checkbox"/> Other standard testing methods <input type="checkbox"/> Non-standard testing methods <input type="checkbox"/> SINAL accredited test report <input type="checkbox"/>
Testing location/ address.....	: Nemko Spa via del Carroccio, 4, I-20046 Biassono MI (Italy)
Applicant's name	: ELCO s.p.a
Address.....	: Via Marconi, 1 20065, Inzago (MI)
Test specification	
Standard	: EN 60529:1991+A1:2000
Test procedure.....	: Nemko WM L0177

Type / Model : MCE 20-25

Equipment : Electronic Control

EN 60529:1991+A1:00 Degrees of protection provided by enclosures (IP code)

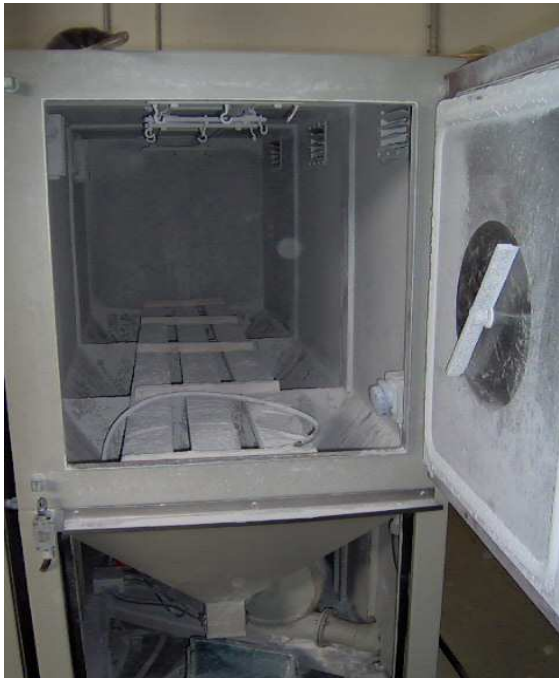
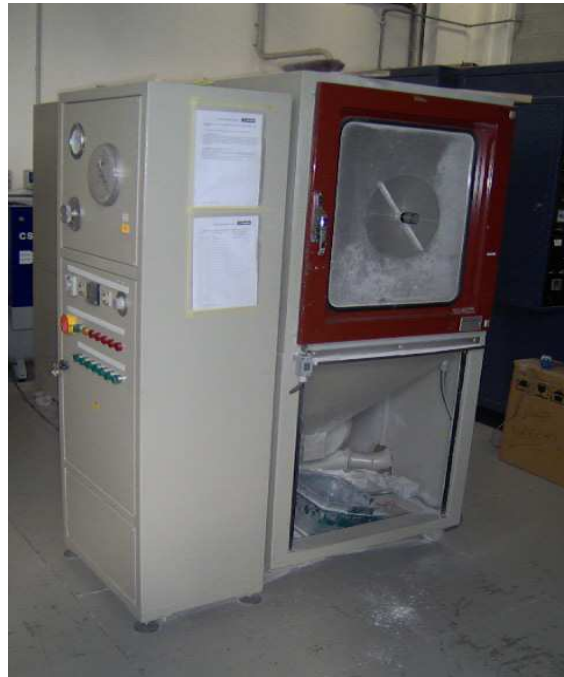
Typical setup for IP Dust test

Test probe diameter.....: 1 mm

Enclosure category.....: 2

Test Duration.....: 8h

Test probe didn't penetrate inside the enclosure.
Dust was not present inside the enclosure and on live parts after test.

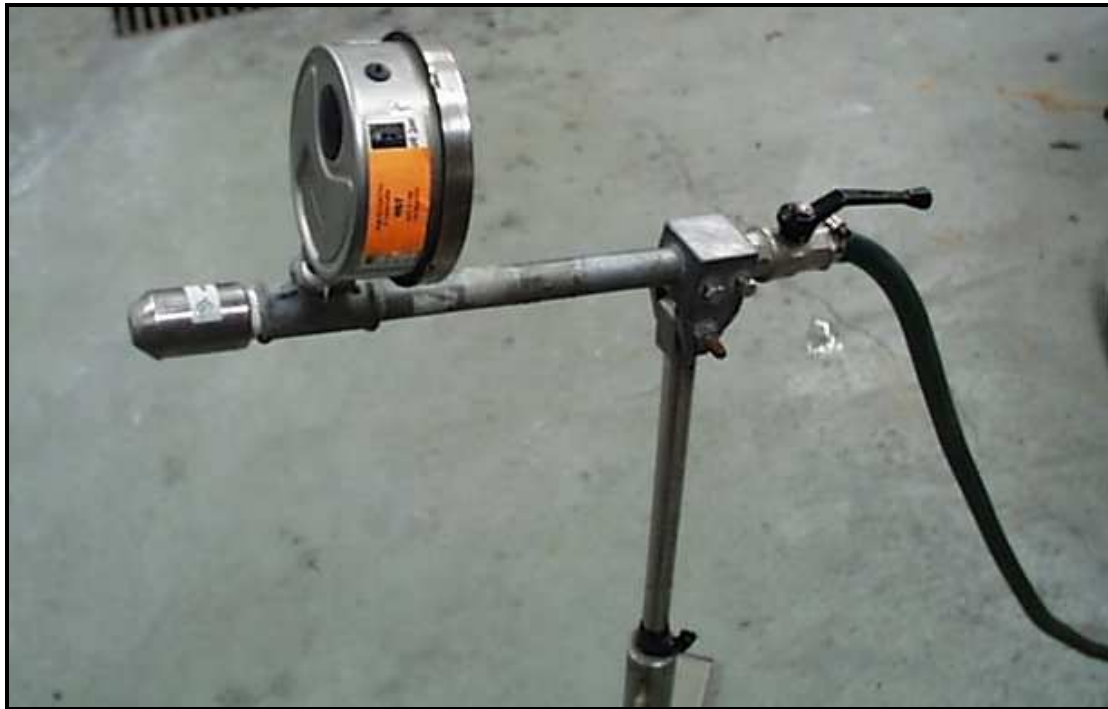
Nozzle for IP X5

Diameter of nozzle.....: 6,3mm
Test duration.....: 3min.
Distance of nozzle to E.U.T.....: from 2,5m to 3m
Water flow.....:12.5l/min

Water was not present inside the enclosure and on live parts after test.

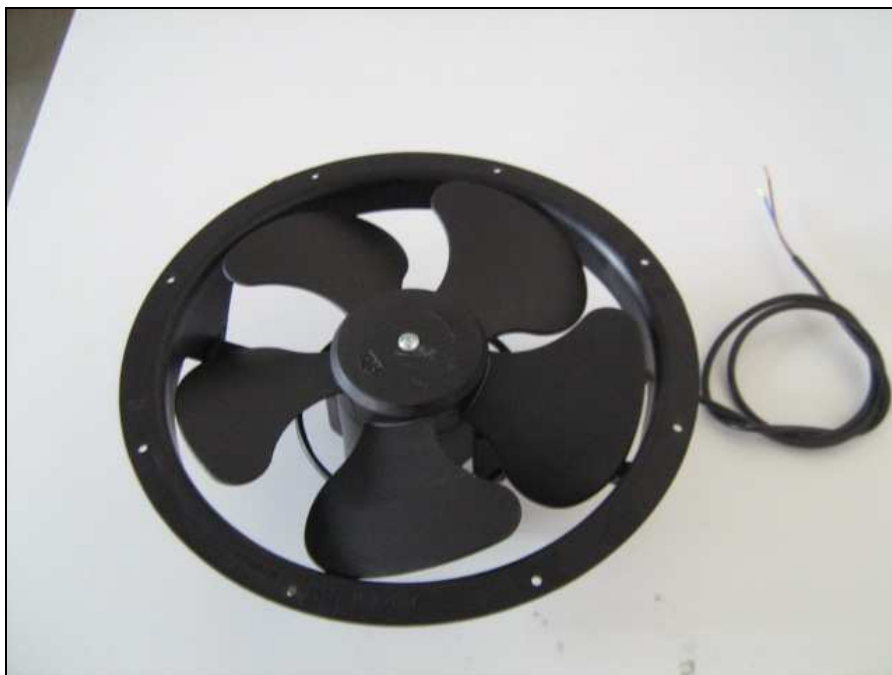
Fig. 1: general view

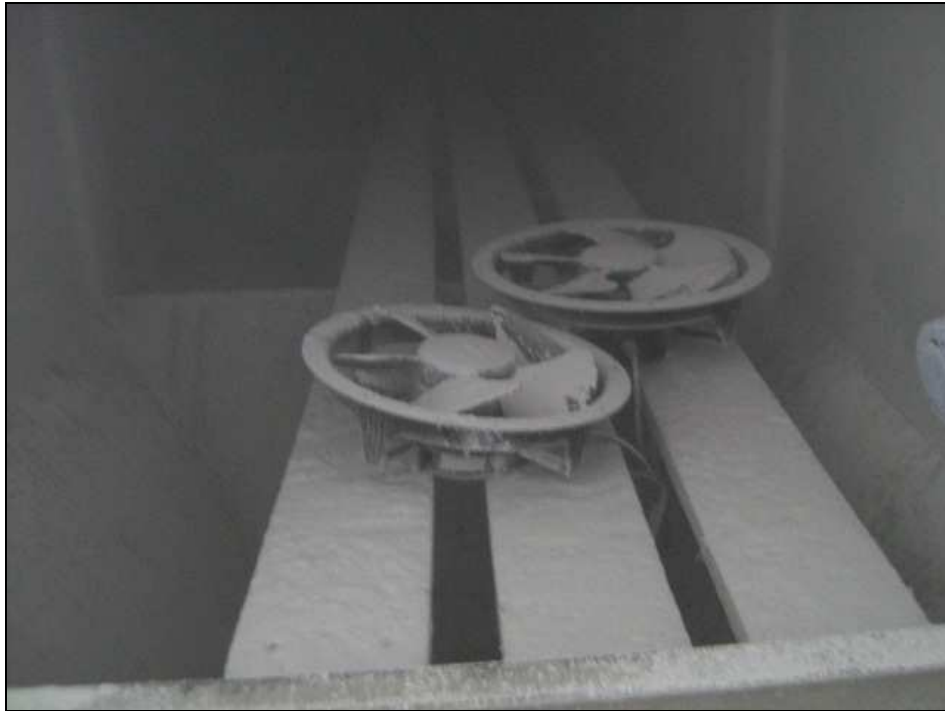
Fig. 2: in a dust test

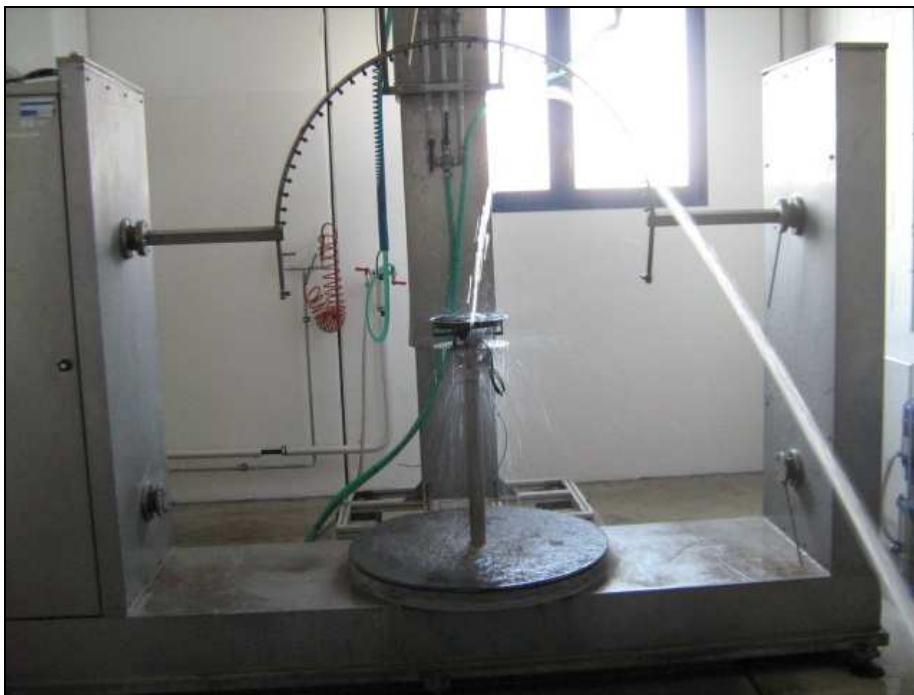
Fig. 3: during the water test

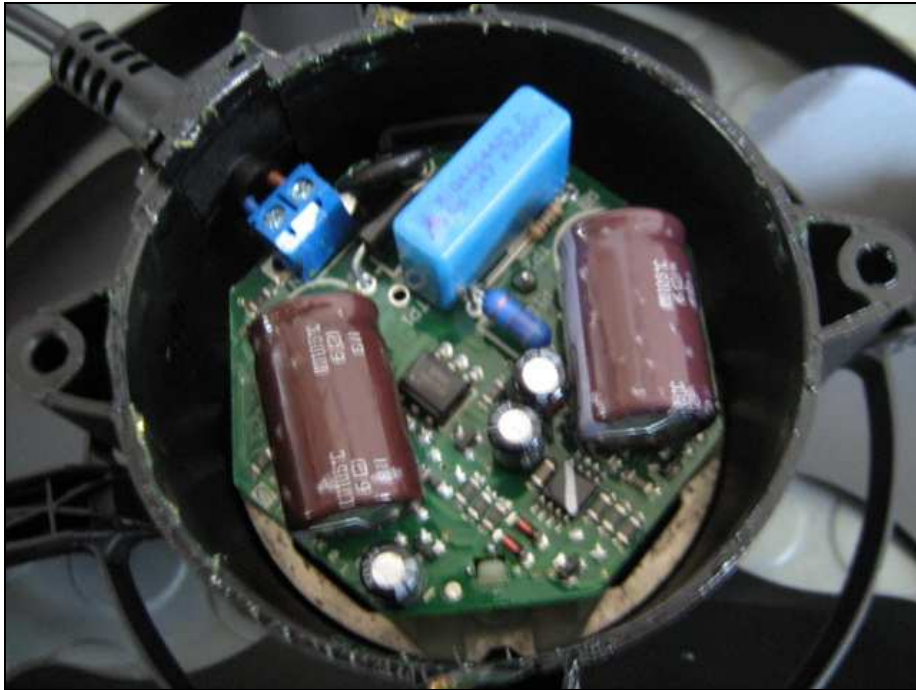
Fig. 4: internal view, after IP65 test

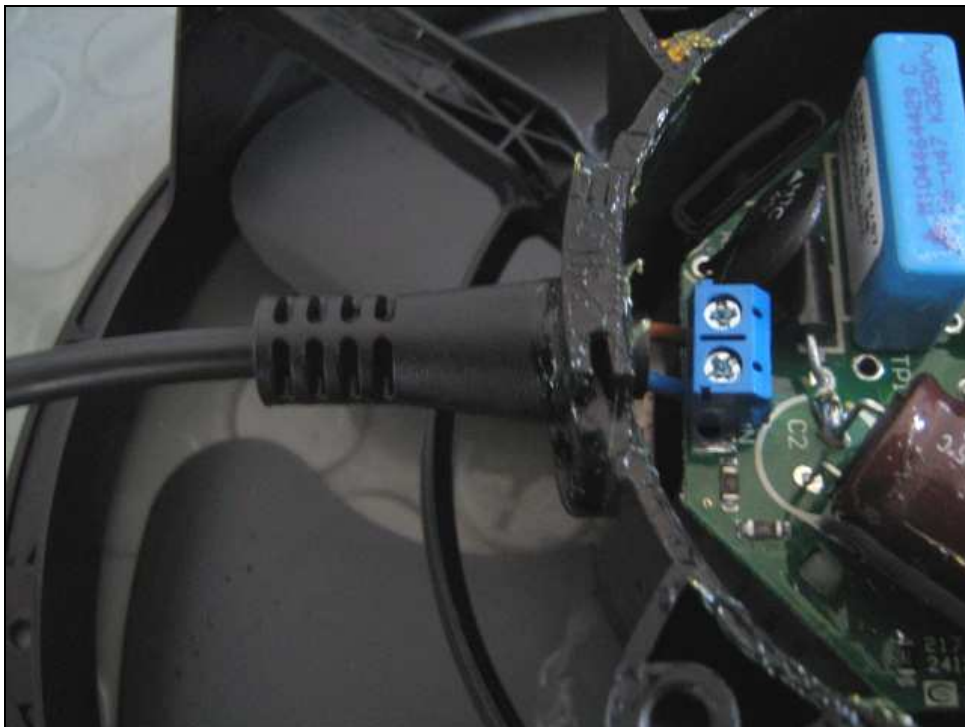
Fig. 5: internal view, after IP65 test
